Property Inspection Report

- Habit Nelson Ltd -

***20 Brooks View Heights, Tasman
Nelson City***

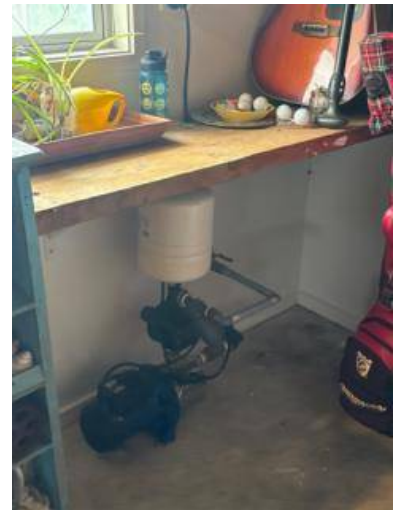
Mains water supply location:

Water pump installed here. **Recommend plumber inspect water bore and tank system installed on this property. Not tested, this is outside of our scope.**

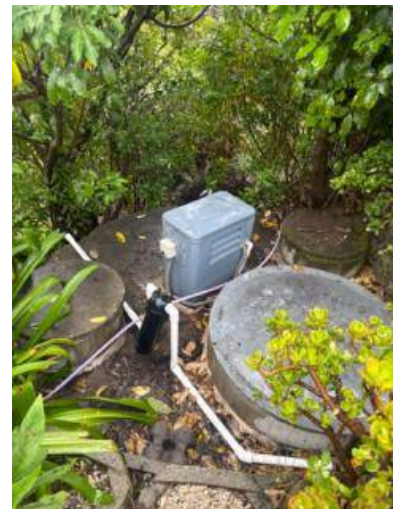
Plumbing:

Sewerage treatment station here, **Not tested, this is outside of our scope.**

For further investigation about the onsite wastewater system, we recommend:

The Drainman 2012 Ltd
Brian Parkinson
Certified Drainlayer
Ph 03 526 8033
Ph 03 544 7521
Cell 0274 387 945
Email info@thedrainman.co.nz.

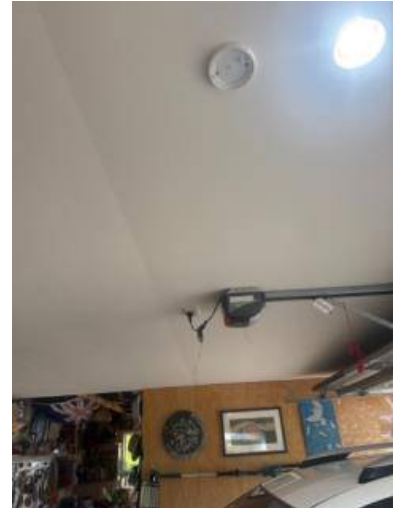
No smoke alarms are fitted in this room on day of inspection.

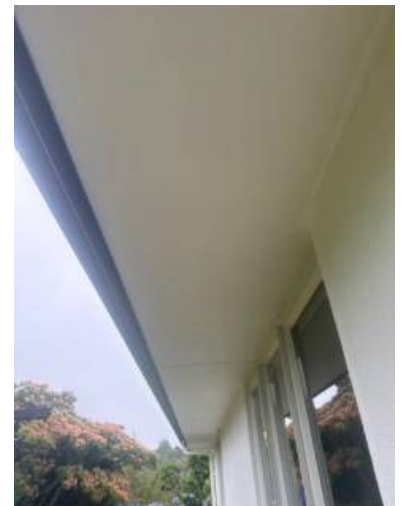
Paint compressed fibre cement, **Possible asbestos eaves** installed here, there is no issue with this product so long as it is kept well sealed, and it is not damaged, cut or drilled into. The only real way to know for sure this is asbestos is to take a sample and get it tested. Secured well, Material in good condition.

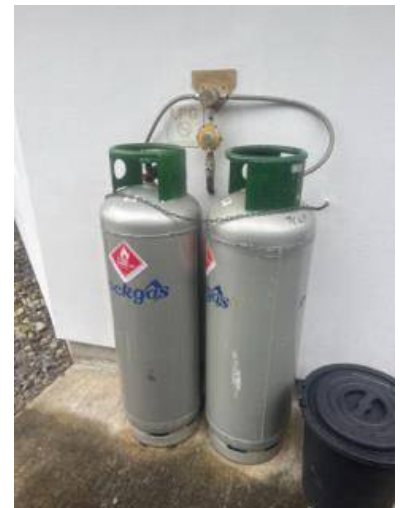
Gas bottles professionally installed. Areas that the gas is used internally, will be logged individually in the respective areas. Gas Cover recommended here to protect gas connections from the elements, Gas bottles for, Gas hob, Gas heating.

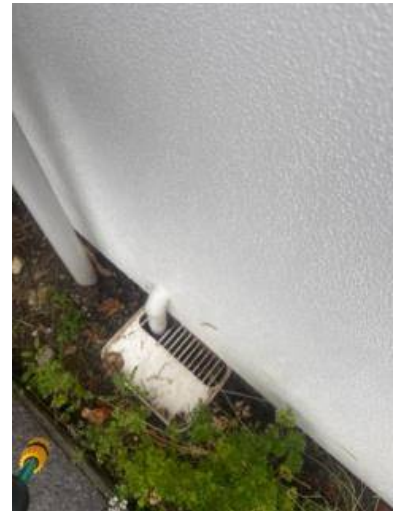
Gully Trap

P.V.C, Drains directly into a septic tank here. (Septic not inspected. Outside scope of works.), Recommend to clean around top of gully trap here and be raised above ground level to meet the code. It is illegal for stormwater to drain into gully traps.

We recommend all drains are checked with a camera and cleared if need be. On our visual inspection we cannot determine the condition of this pipe work. Blocked drains can occurred at any time so it does pay to check, even though there were no signs on inspection.

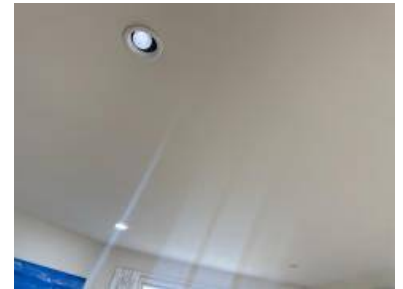
Bulbs blown, most likely the case of blown bulbs but it is up to the vendor to get these changed to know for sure it is only a bulb and nothing to do with the wiring.

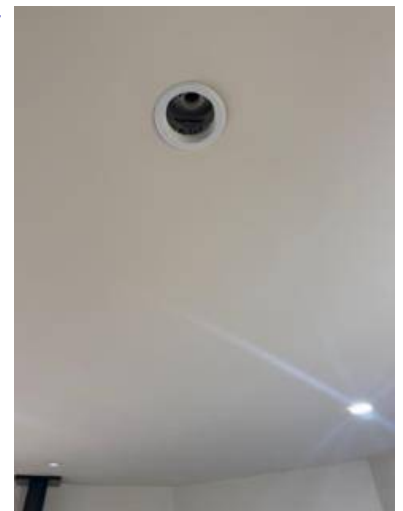
light bulbs missing here. I do suggested you get the current owner to get these changed to be sure it is only a bulb and nothing to do with the wiring.

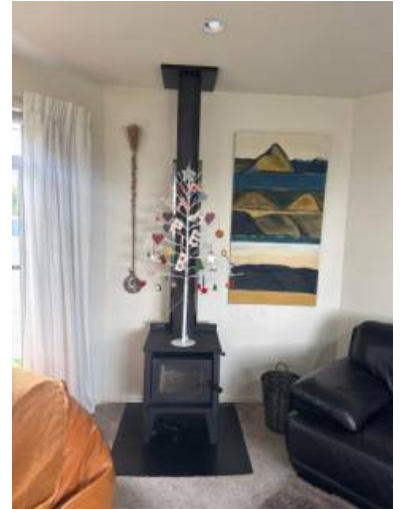
Free standing Wood burner. **Not tested or inspected, this is outside of our scope.** Do Not Use until cleaned and checked by a professional in this area before use. There is no way of telling when this was last used. check council records to make sure fireplace meets current building code.

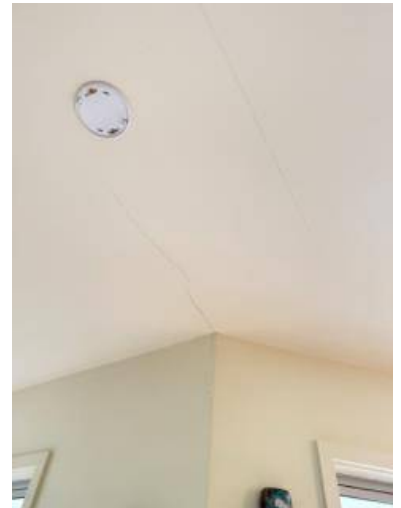
Base linings intact, Good Condition, Base linings intact, Cracking evident to the plaster joins on the ceiling area this is a common place where you will get movement. Recommend to plaster over with paper tape to prevent cracking. Gib stopper required.
