# Healthy Homes Inspection Report

| Property Address | 3/155 Waimea Road, Nelson |
| Inspection Date | 15 January, 2021 |
| Job ID | 162369 |

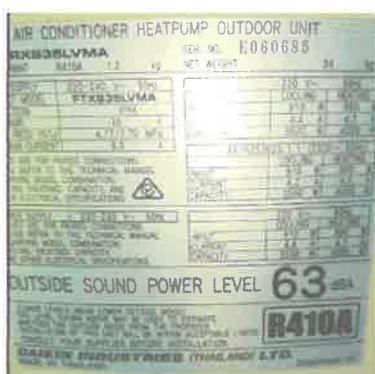
Comment:  
Heat pump capacity insufficient

**FAIL** ✖

| Required Capacity (kW), see Appendix One | 4.7 | Actual Capacity (kW) | 4 |
| Heat source type | Heat Pump | Heat source make | Daiken |

Existing heat source has insufficient capacity. Recommend fitting top up heater.

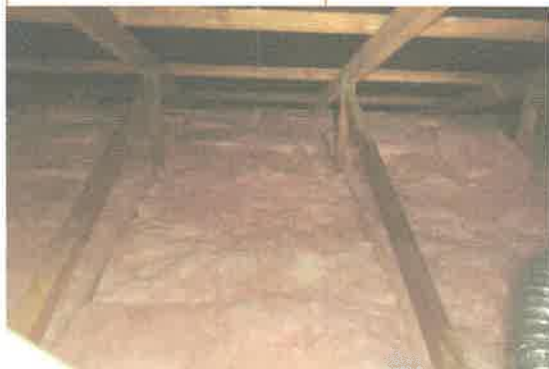
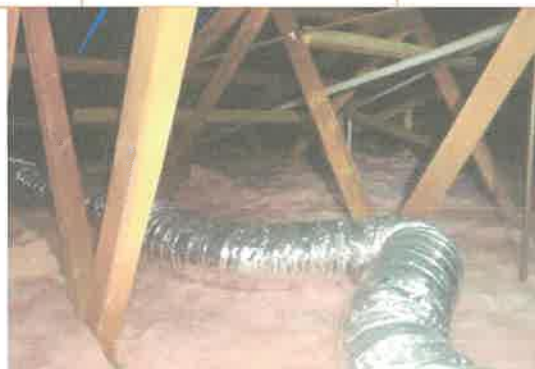
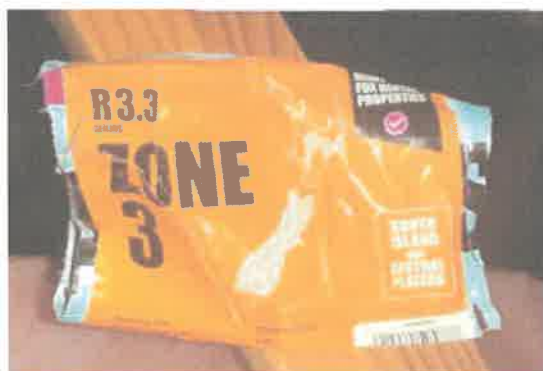
### Ceiling:

| Type | Glasswool over Insulfluff | Condition | Good |
| R-Value | 3.3 | Thickness | 170mm |

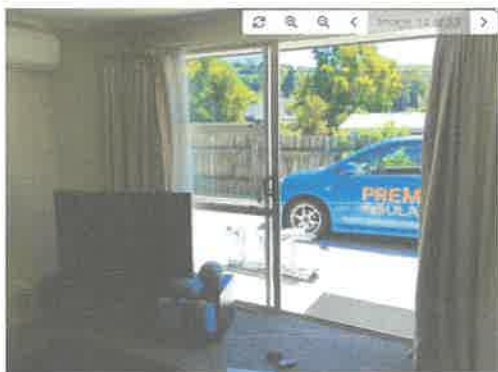
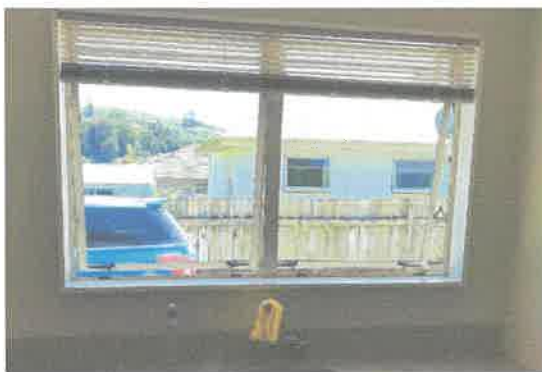
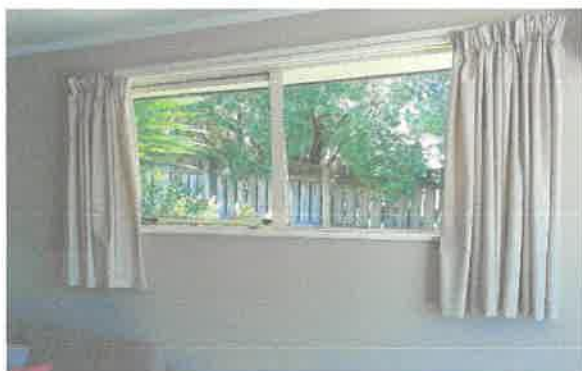
#### Kitchen / Dining / Living – Openable Window/s

| Floor Area (m <sup>2</sup> ) | 30 | Required opening (m <sup>2</sup> ) | 1.5 |
| Existing opening (m <sup>2</sup> ) | 5.7 | Pass? | ✓ |

No action required

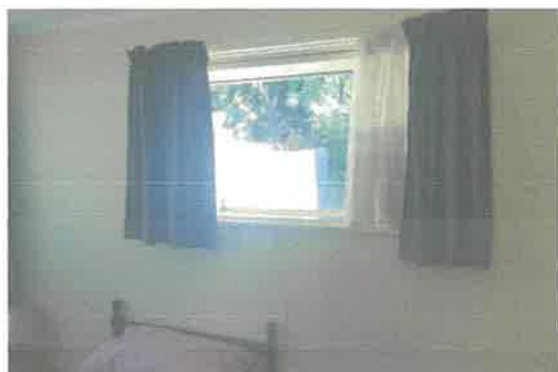
**Bedroom 1 – Openable Window/s**

| Floor Area (m <sup>2</sup> ) | 8.6 | Required opening (m <sup>2</sup> ) | 0.4 |
| Existing opening (m <sup>2</sup> ) | 1.5 | Pass | ✓ |

No action required

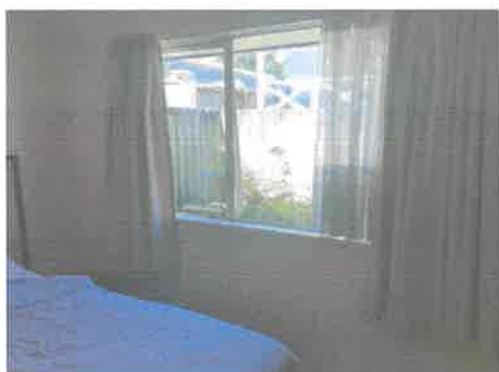
### Bedroom 2 – Openable Window/s

| Floor Area (m <sup>2</sup> ) | 9.8 | Required opening (m <sup>2</sup> ) | 0.5 |
| Existing opening (m <sup>2</sup> ) | 0.7 | Pass? | ✓ |

No action required

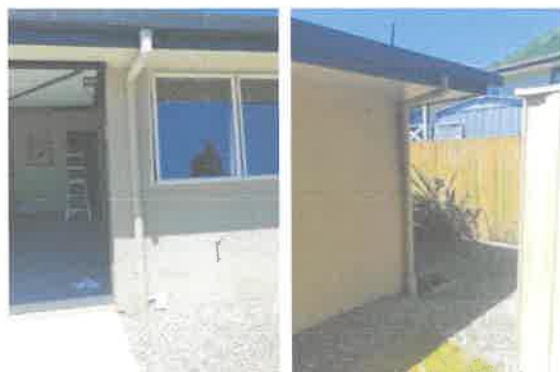
### Guttering and Downpipes

| Appropriate gutters present? | ✓ | Gutters connected to downpipe? | ✓ |
| Gutters and downpipes sufficiently sized? | ✓ | Gutters have sufficient fall? | ✓ |
| Gutters and downpipes are intact? | ✓ | Gutters and downpipes free of blockages? | ✓ |
| Downpipes direct water to appropriate outfall? | ✓ | | |
