Property Inspection Report

- Habit Nelson Ltd -

***20 Brooks View Heights, Tasman
Nelson City***

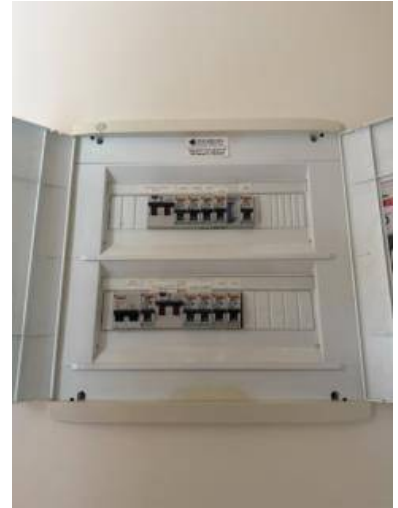
Mains power fuse board is found in the hallway area. All modern fuses are installed here. **Legally we are not allowed to open this mains power board up, this is up to a registered electrician.**

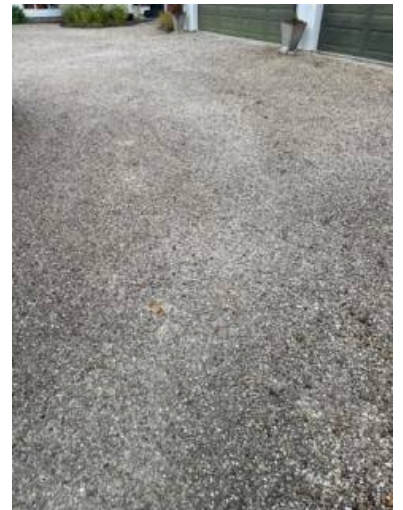
Driveway:

Shingle, Material in reasonable condition.

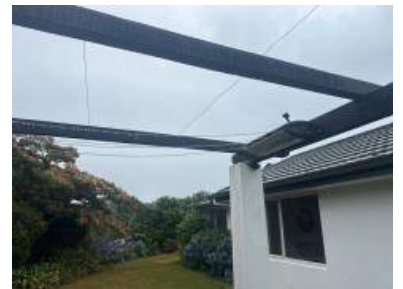
Clothesline:

A Retracting clothes line is installed here. Material in reasonable condition.

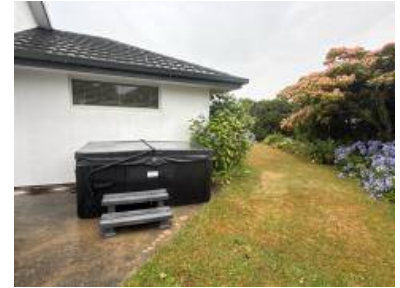
Spa Pool area , Check council records to make sure spa pool area meets the current building code. **Not tested, this is outside of our scope.**

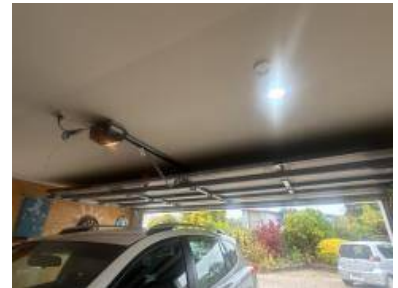
Main Door:

Automatic sectional door fitted here, Garage door is in reasonable working condition.

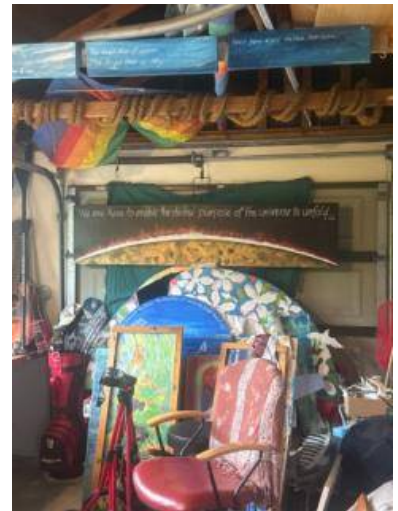
Sectional door fitted here. Not opened on day of inspection.

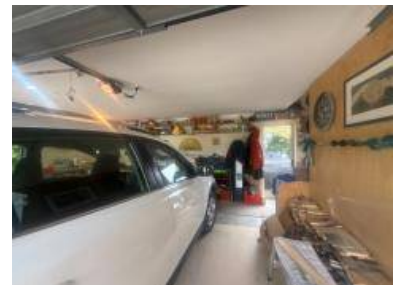
Internal linings:

Base linings intact, Reasonable Condition.

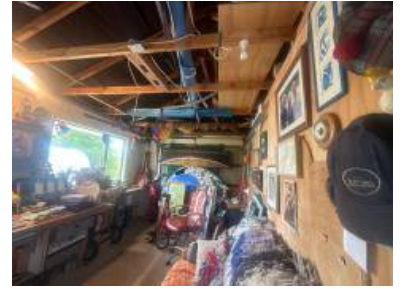
Base linings intact, Reasonable Condition.

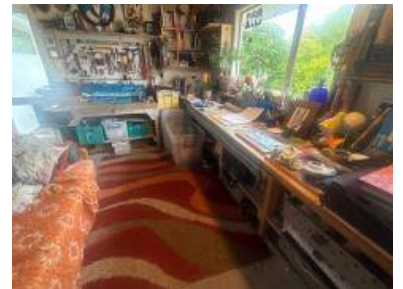
Work bench, Workshop area, Material in, Reasonable Condition.

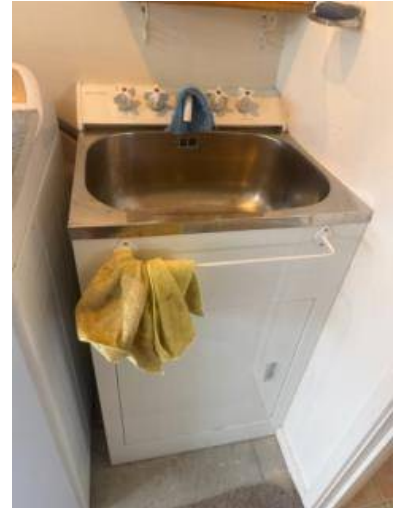
Tub:

Super tub with necessary washing machine connections, Draining well without blockages. Material in Reasonable Condition.

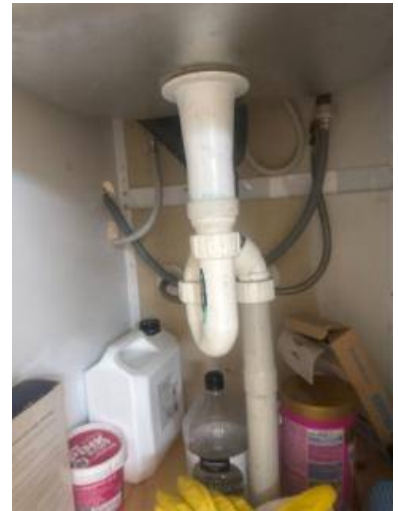
Tub Plumbing

The hot and cold water feeds to this area are Modern PVC Plumbing Flexi hoses also installed here. The pipe work under the sink is functioning well under pressure, pipe work is in, good condition.

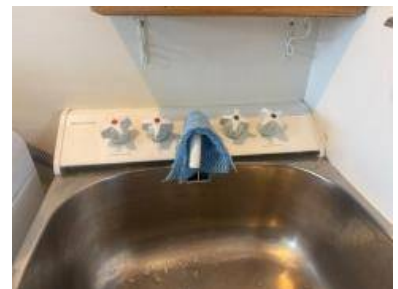
Tub Taps:

Two single taps into a single mixer, Good water pressure, Draining well without leaks or blockages

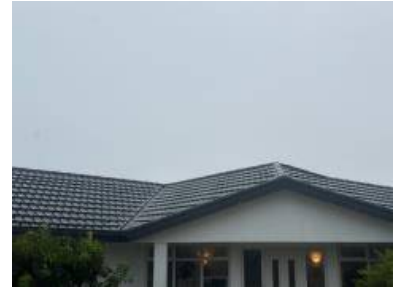
Roof cladding main:

Color steel Tile, Only viewed from the ground as it was unsafe to gain access onto the roof due to the weather conditions and in accordance with "Work Safe New Zealand" working at height regulations.

Material in reasonable condition.

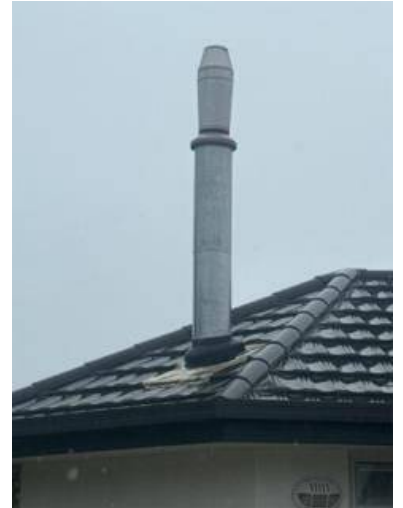
Chimney:

Galvanised Iron, Well secured, Operational, Material in reasonable condition.

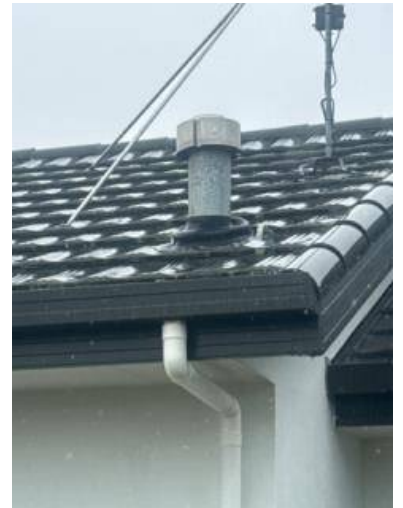
Galvanised Iron, Well secured, Operational, Material in reasonable condition.

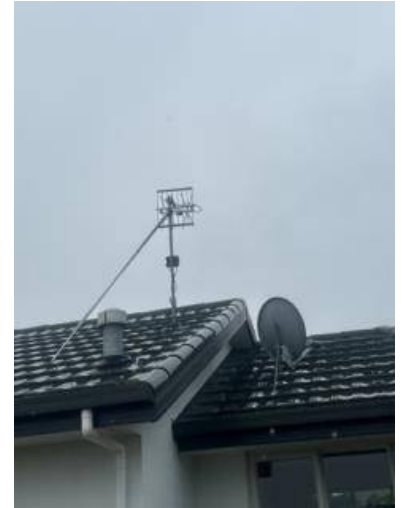
Aerials:

Multi Installed Secured Well, Good Condition.

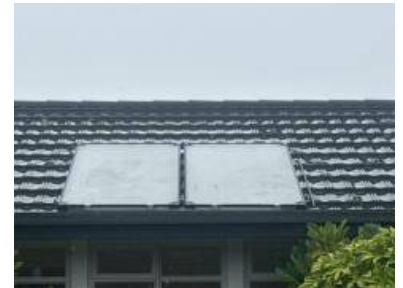
Solar:

Solar panels installed here, **not tested outside scope of work.** Solar panels are in, reasonable condition.

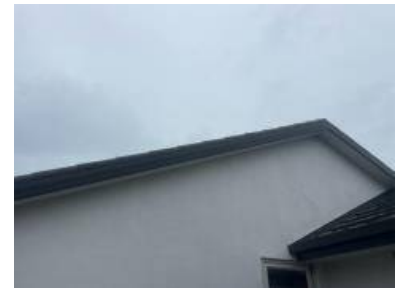
Fascia:

Metal Fascia, Material in good condition.

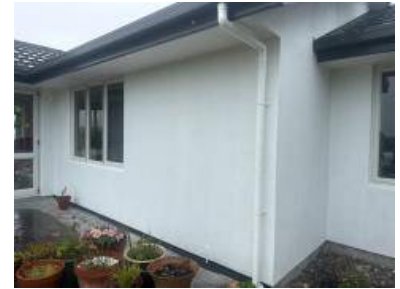
This is not a leaky home report or a specialist inspection, a visual inspection only has been carried out. Material in good condition.

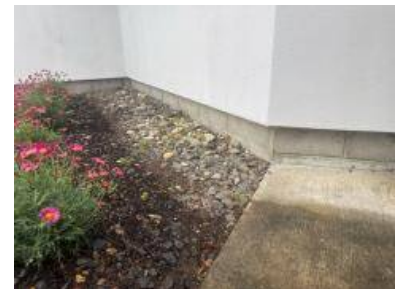
Ground Clearances:

Good ground clearance from the finished ground level outside to the finished floor level inside.

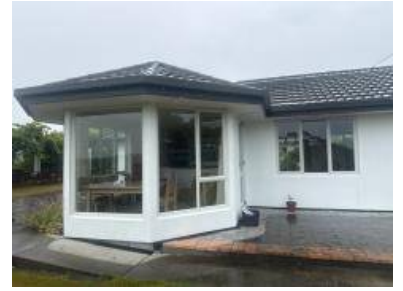
Aluminium, single glazed, Material in good condition.

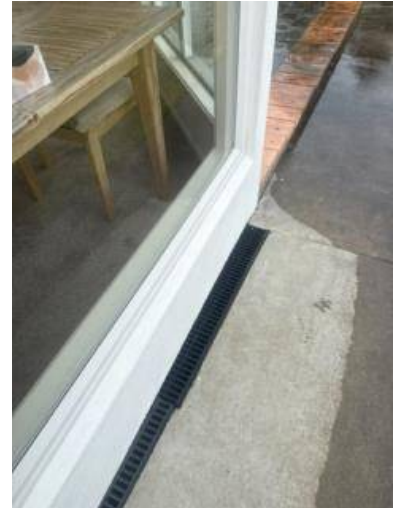
Window sills

Plaster finish, Material in reasonable condition.

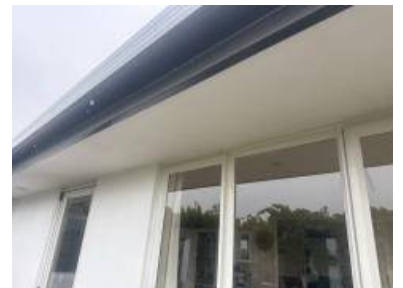
Flashings over windows and door areas:

No flashings over the door and windows, not required.

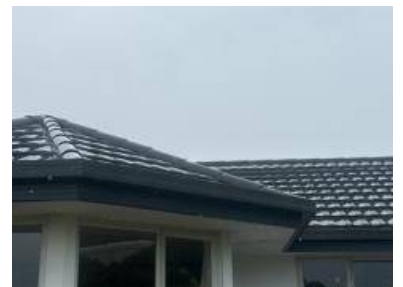
Guttering:

Colour Steel, Secured, Material in good condition.

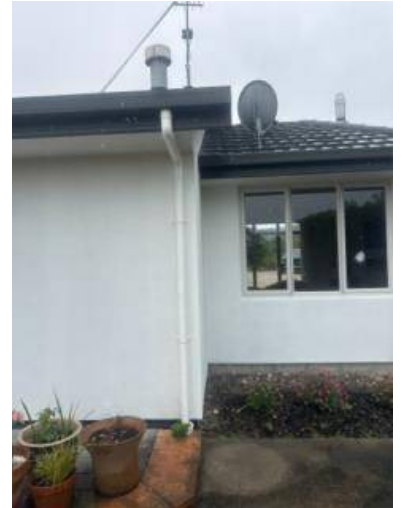
Downpipes:

PVC, Secured, Drains into holding tanks on site, Drains into stormwater outlet.

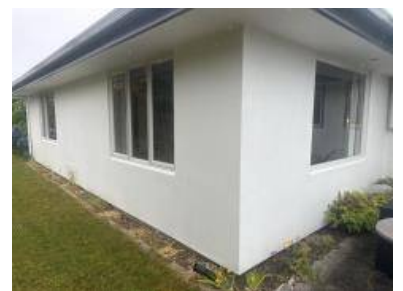
Paint:

Paint is in a good Condition.

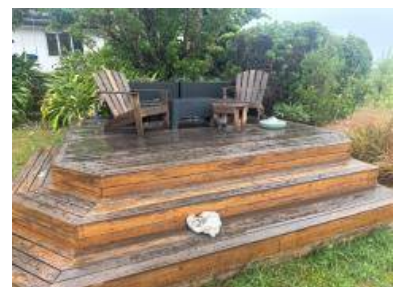
Ground Floor Deck:

Timber decking
Timber framing installed, Material in reasonable condition.

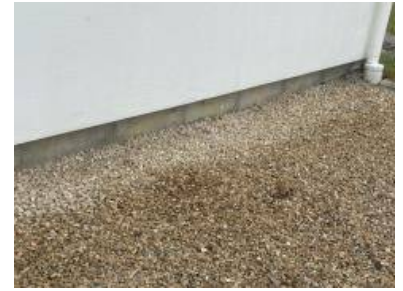
Foundation:

Reinforced concrete block ring, Concrete Floor, Material in good condition.

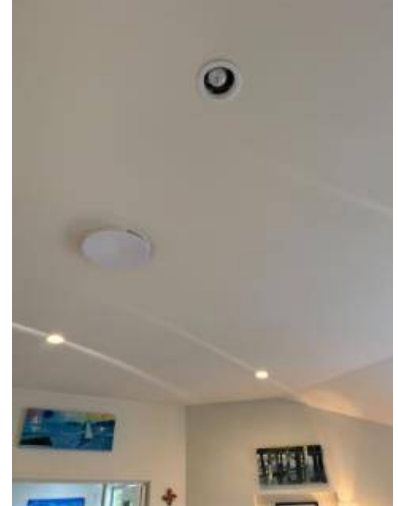
Tested:

Bulbs blown, most likely the case of blown bulbs but it is up to the vendor to get these changed to know for sure it is only a bulb and nothing to do with the wiring.

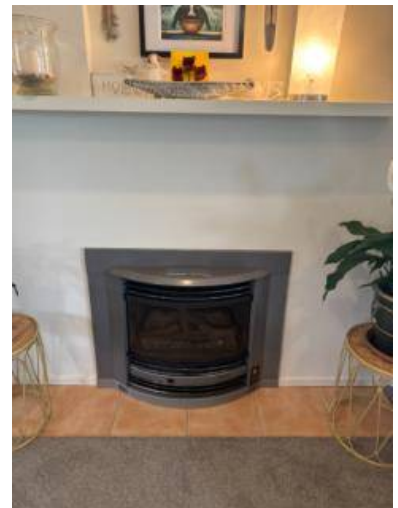
Heating:

Built in gas fire. **Not tested, this is outside of our scope.** We suggest that all gas fixtures are checked and cleaned by a registered plumber - gas fitter, as these appliances are aged, valves and ignitions can go at any time.

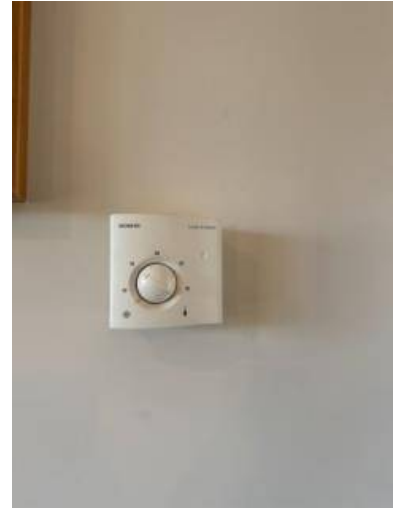
Ventilated Ducted System:

Heat Transfer Fan system is install here, The control panel is located here. See [internal ceiling space for condition on ducting](#).
Not tested, this is outside of our scope.

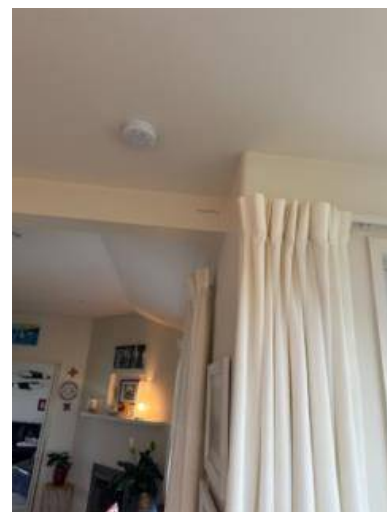
Smoke Alarms:

Battery smoke detector fitted in this room. Securely Installed, Tested. Working on day of inspection.

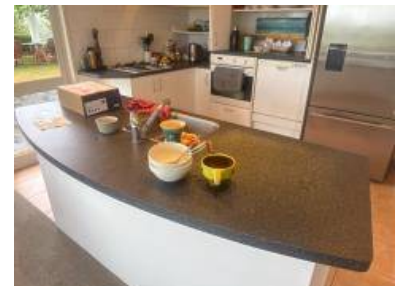
Kitchen bench top:

Formica, Kitchen bench top is in, reasonable condition.

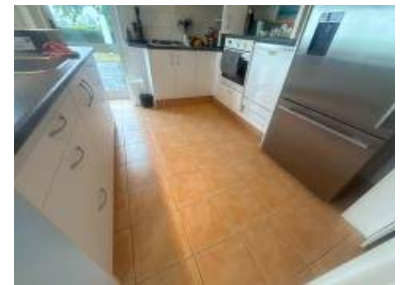
Kitchen joinery units:

Kitchen joinery units are in, reasonable condition, functions adequately.

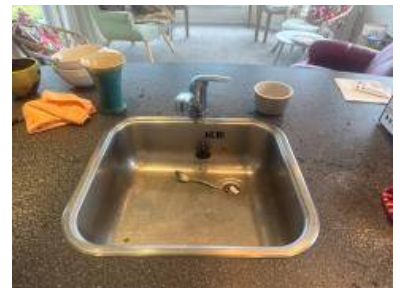
Kitchen sink area:

Single, Stainless steel, Draining well without blockages. Sink insert is in Reasonable condition.

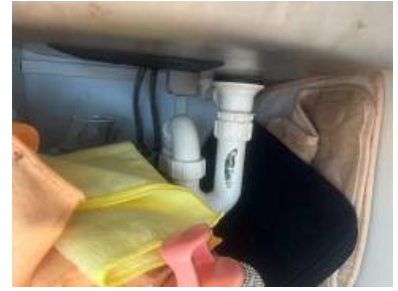
Kitchen plumbing:

The hot and cold water feeds to this area are Modern PVC Plumbing Flexi hoses also installed here. The pipe work under the sink is functioning well under pressure, pipe work is in, reasonable condition.

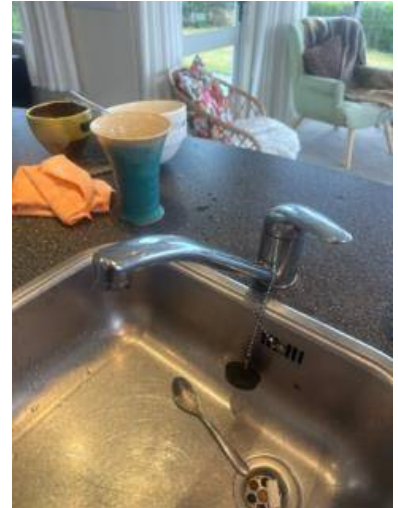
Kitchen tap:

Single water mixer, Kitchen tap has good water pressure, Draining well without leaks or blockages

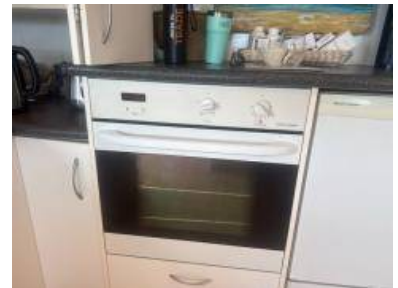
Oven:

Older style oven, Wall mounted design, Tested, working. **Be aware thermostats are not checked. This is a specialized inspection which we do not carry out. We simply check if the oven heats up or not.** Oven is in Reasonable condition.

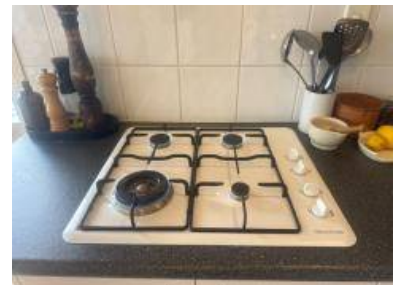
Oven cook top:

4 Gas hob **We suggest that all gas fixtures are checked and cleaned by a registered plumber - gas fitter, as these appliances are aged, valves and ignitions can go at any time.** Heat shield fitted, Tested, working, Cook top is in Reasonable condition, **Remedial attention required, Right front, Hob not working, Gas fitter required.**

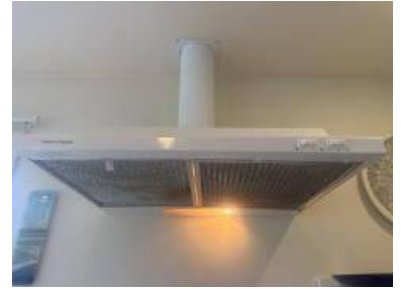
Range hood installed, Tested, working, Rangehood is in Reasonable condition.

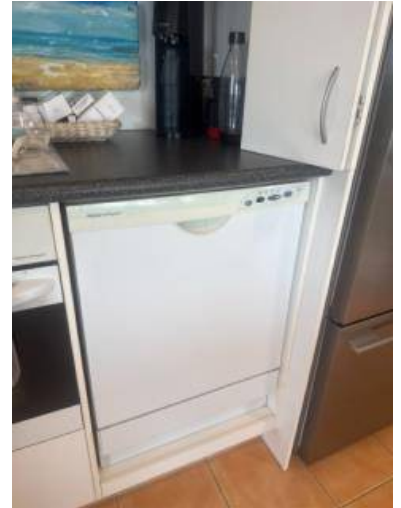
Dishwasher installed, Dishwasher is in reasonable condition, **Not tested, this is outside of our scope.**

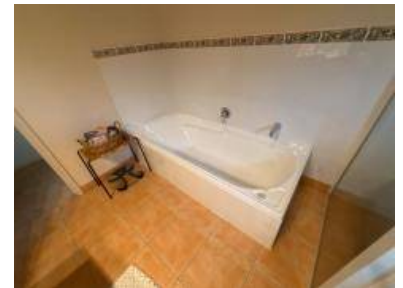
Bath:

Built in Bath, Tile surround, Good bath surface and surround.

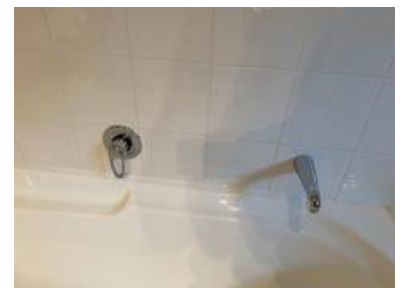
Bath Taps:

1 water mixer into faucet over bath, Good water pressure, Draining well without leaks or blockages

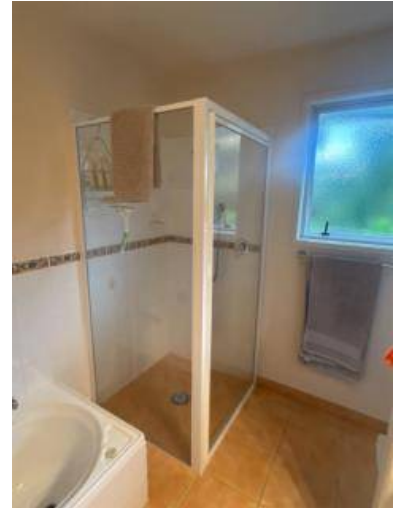
Shower:

Tile surround These tiles should have a water proofing membrane installed behind them, this is done before tiling by the tiler. A certificate of guarantee for both the workmanship and the product should also be supplied.

Glass surround, Shower in good Condition.

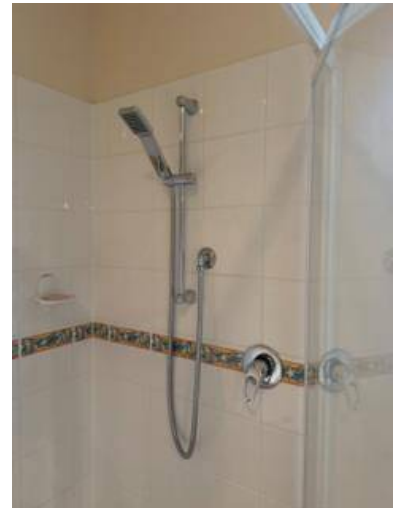
Shower Water Control:

Hand held shower rose, Single mixer, Good water pressure.

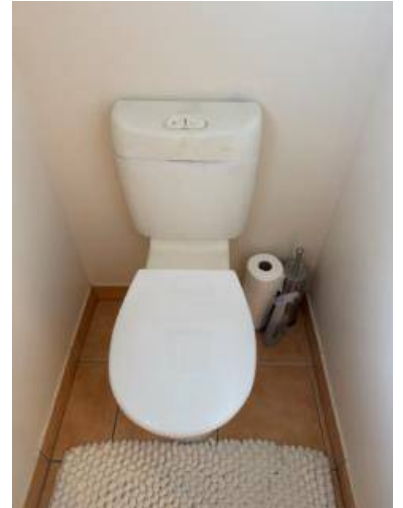
Double flush plastic cistern, Reasonable Condition.

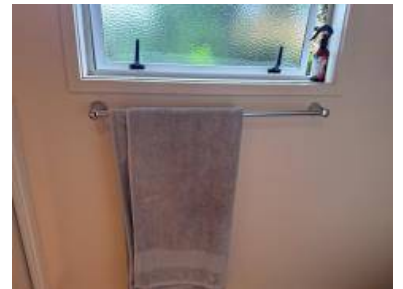
Towel Rail:

Towel rail, Well secured & in good condition.

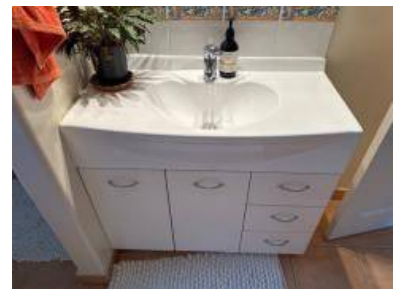
1 unit, Draining well without blockages, Good Condition, minor ageing. Draining well without leaks or blockages.

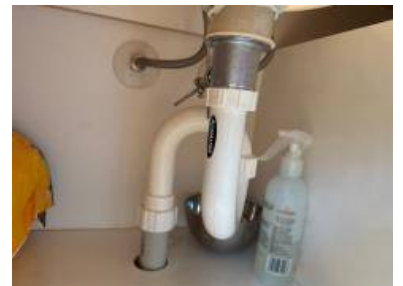
The hot and cold water feeds to this area are Modern PVC Plumbing Flexi hoses also installed here. The pipe work under the sink is functioning well under pressure, pipe work is in, good condition.

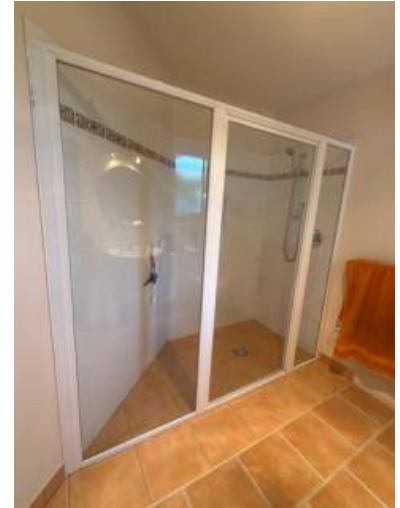
Glass surround, Shower in good Condition.

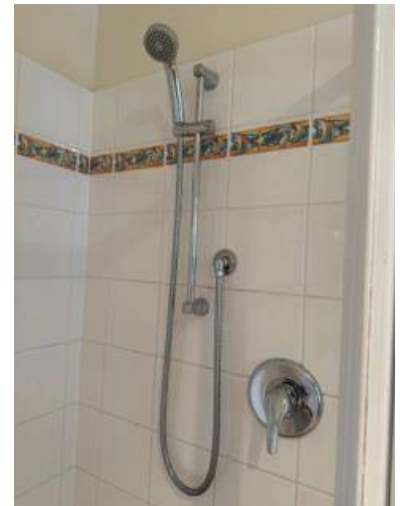
Hand held shower rose, Single mixer, Good water pressure.

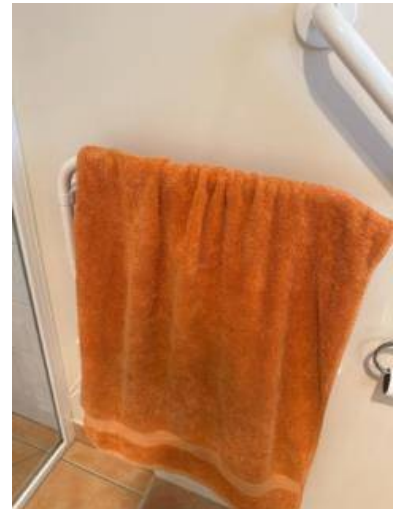
Heated towel rail, **Not tested, this is outside of our scope**, Well secured & in good condition.

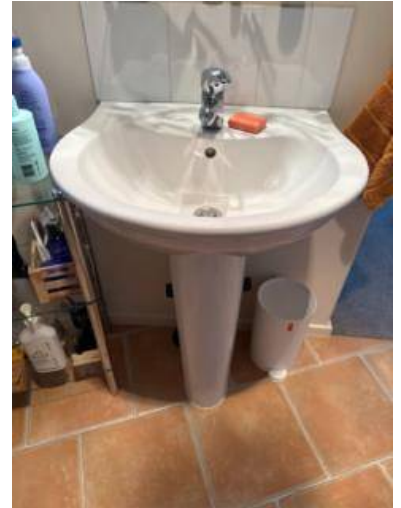
1 unit, Draining well without blockages, Good Condition, minor ageing. Draining well without leaks or blockages.

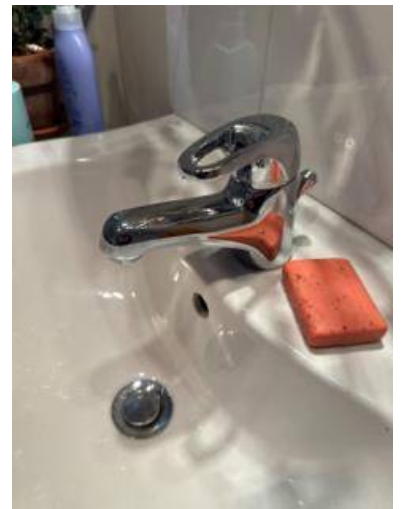
Single water mixer, Good water pressure, Draining well without leaks or blockages

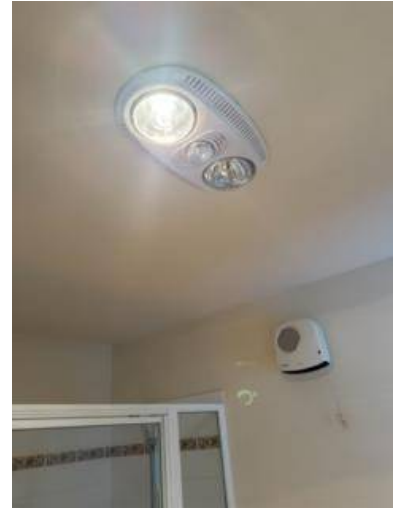
Heat lamp, extraction unit and lighting system, Fan tested in reasonable working order. **Requires remedial attention, Light bulb needs replacing, Heat lamp needs replacing.**

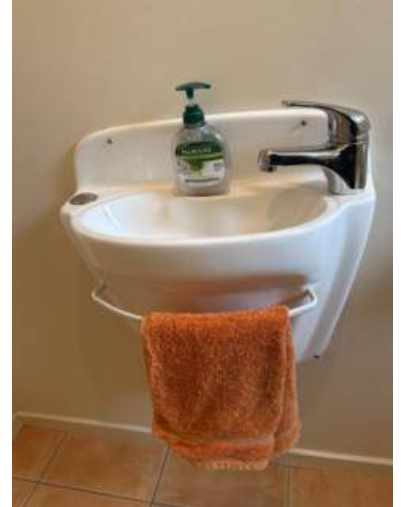
1 unit, Draining well without blockages, Good Condition, minor ageing. Draining well without leaks or blockages.

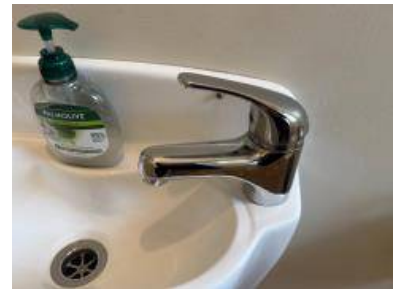
Single water mixer, Good water pressure, Draining well without leaks or blockages

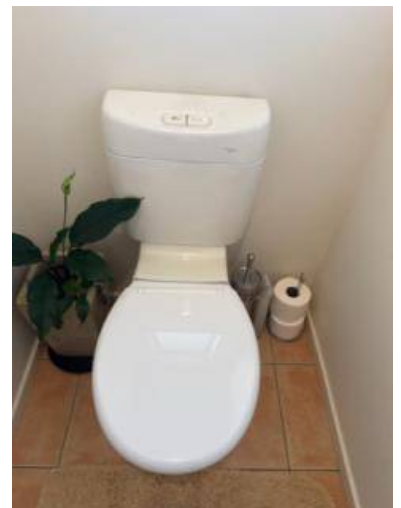
Double flush plastic cistern, Reasonable Condition.

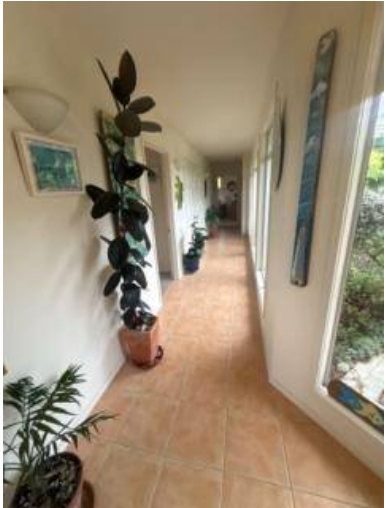
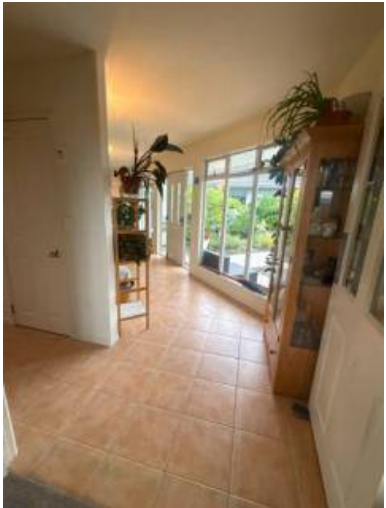
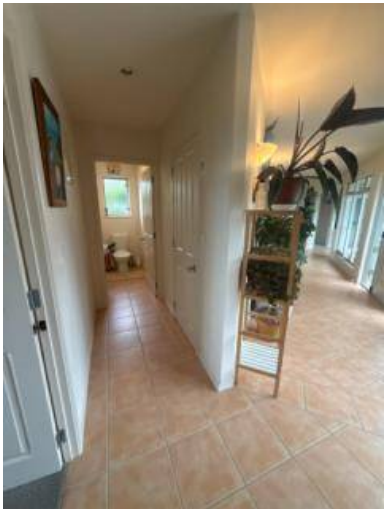
Base linings intact, Good Condition, Base linings intact, Cracking evident to the plaster joins on the ceiling area this is a common place where you will get movement. Recommend to plaster over with paper tape to prevent cracking. Gib stopper required.

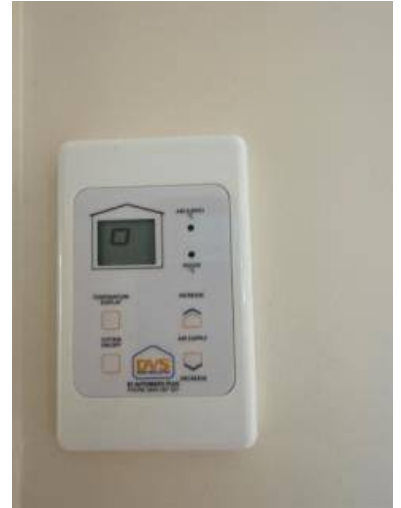
DVS ventilation system is install here, The control panel is located here. See internal ceiling space for condition on ducting. Not tested, this is outside of our scope.

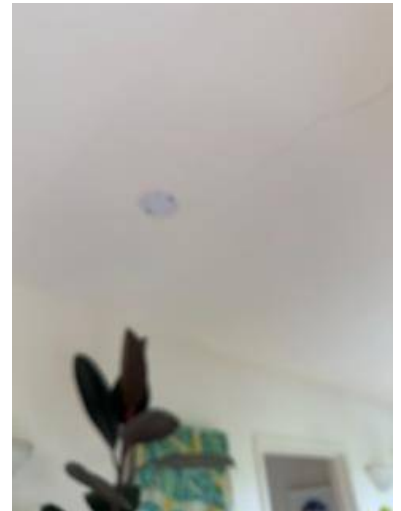
No smoke alarms are fitted in this room on day of inspection.

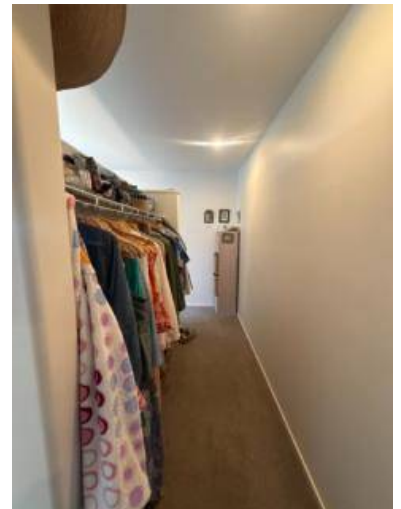
Walk in design, Internal storage areas installed
Lighting installed, Tidy Area.

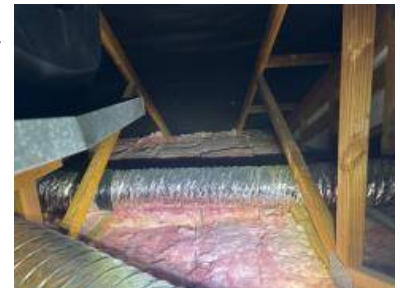
Roof lining

Lining paper, Lining paper installed here is in a reasonable secure condition. Minor signs of ageing, or areas requiring minor re-fixing but no major issues here.

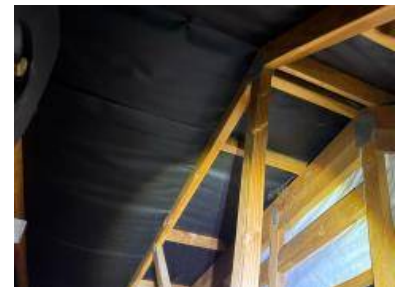
Roofing type

Factory manufactured trusses installed here, The factory manufactured trusses are in a reasonable condition. Signs of ageing evident here, but no issues with the timber or securing methods.

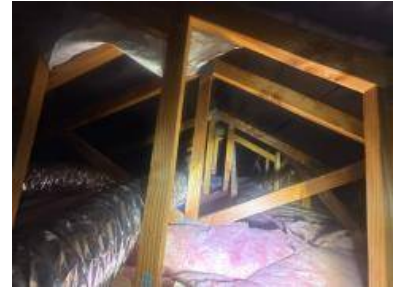
Plumbing

Combination, Copper, P.V.C, Lagged or insulated, The plumbing installed here, is reasonably well secured, shows signs of ageing, but there is no evidence of any moisture leaks.

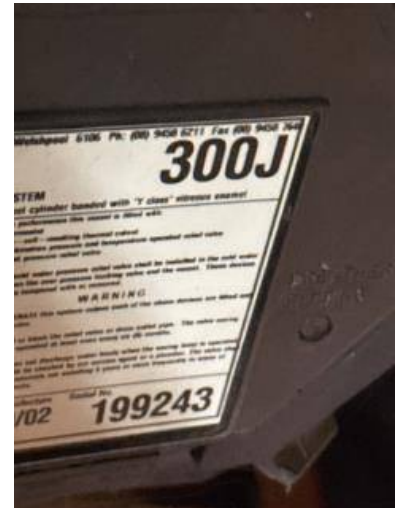
Pressure:

High Pressure.
